**MEMORIAL PARK  
MANAGEMENT PLAN  
BRISTOL, VERMONT**

Bristol Conservation Commission

Approved by Bristol Selectboard 30 October 2023

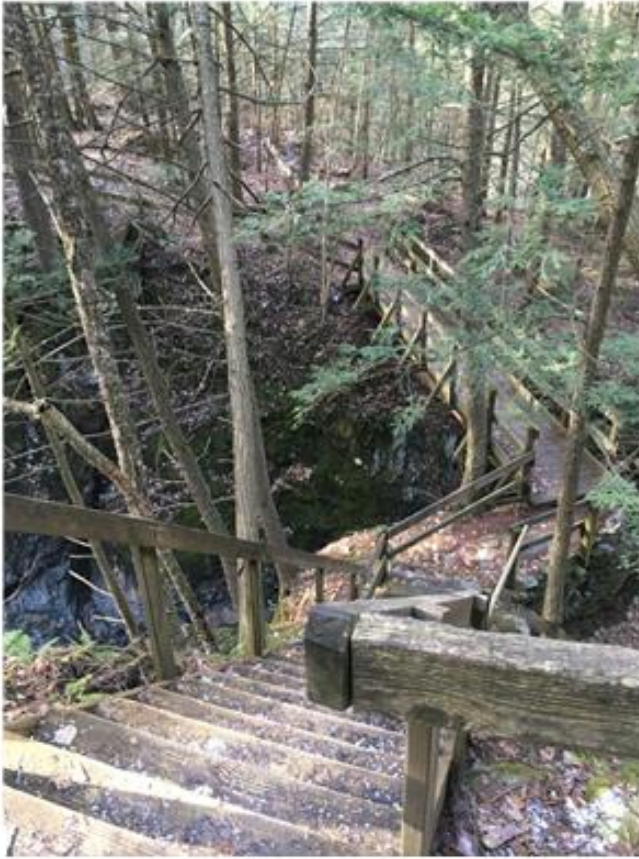
*Figure 4. Original wooden staircase leading to footbridge over chasm for viewing Burnham Falls. Due to deteriorating conditions and safety concerns, this staircase was dismantled in the fall of 2019, and the bridge trail was closed until further notice.*

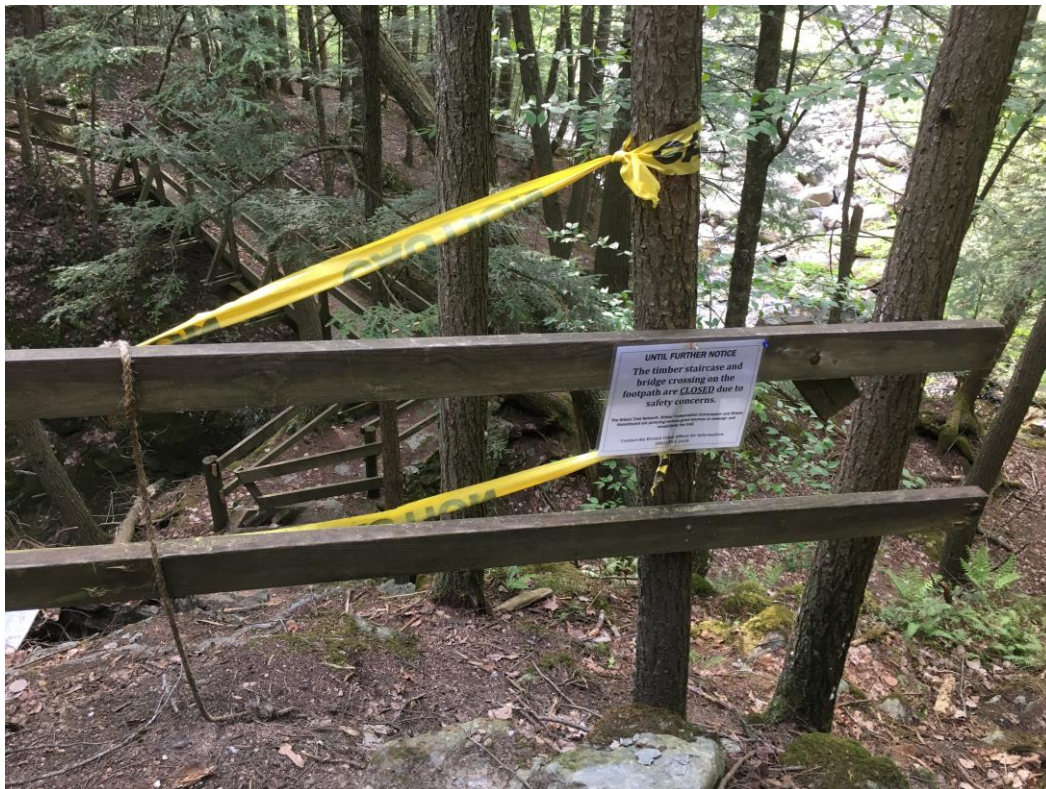
*Figure 7. Signage, caution tape, and wooden planking mark the end of the footpath and closure of the bridge crossing at Memorial Park.*

Nature trails and a timber bridge on steel I-beams were developed at the park in the 1960s, so that users would have access to view the falls, and explore the ecology and geology of the park. Conditions of the trail, timber steps, railings and bridge have since deteriorated over the decades. Originally, the trail system to access this bridge included a steep wooden staircase to traverse a steep bedrock slope (Figure 4). Due to deteriorating conditions of this staircase and related safety concerns, it was dismantled by the Conservation Commission in the fall of 2019, and the bridge trail was closed until further notice. Wooden planking and caution tape along with signage are used to block the trail at the former location of the head of staircase (Figure 7). Caution tape was also used to block access to the east end of the bridge. During weekly inspections of this area, the Recreation Department has reported occasional breaching of the caution tape, and has reinstalled the tape.
